# **STRESS FRACTURE ON A BOEING 757 : OBSERVATIONS BY A GEOLOGIST**

May 21, 2012

Richard R. Donofrio

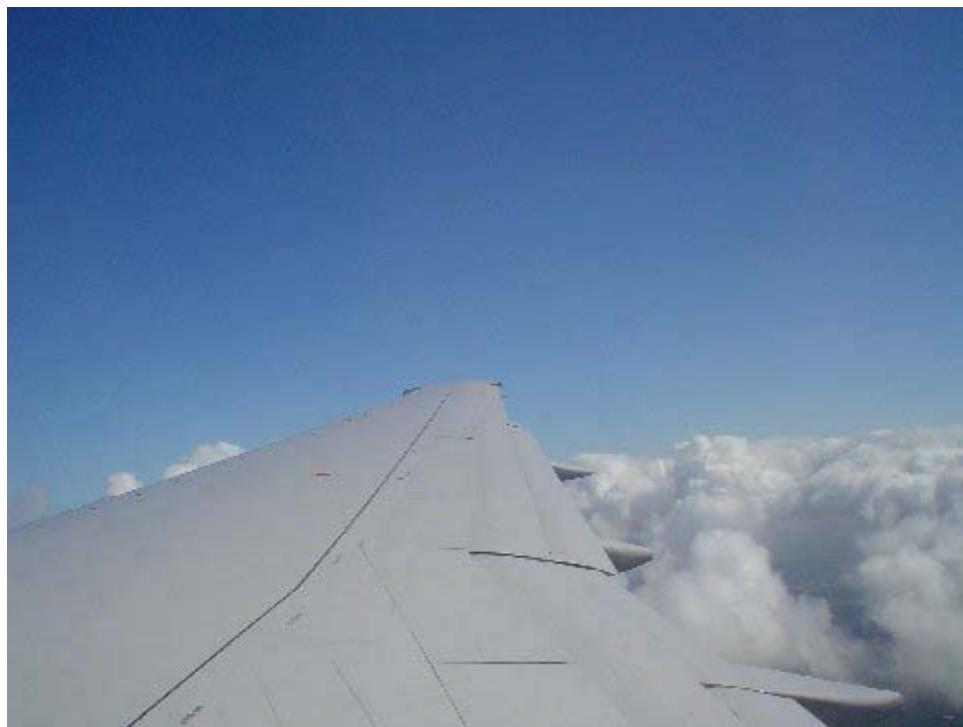
**Photo 1. Passenger's view of 757 wing**

This is a passenger's view from a seat over the ~ 60 foot (18 meter) wing of a 757. The outboard and inboard flaps are starting to deploy for landing (outboard flaps are farthest on the wing). The eye clearly sees a fracture on the outboard flaps. Distance of the aircraft window to the closest segment of the fracture is about 26 feet (8m). A picture is taken, but the fracture cannot be recognized in the small viewing screen of the camera. When the photo is later enlarged and enhanced using a software imaging program, this picture emerges (next page).

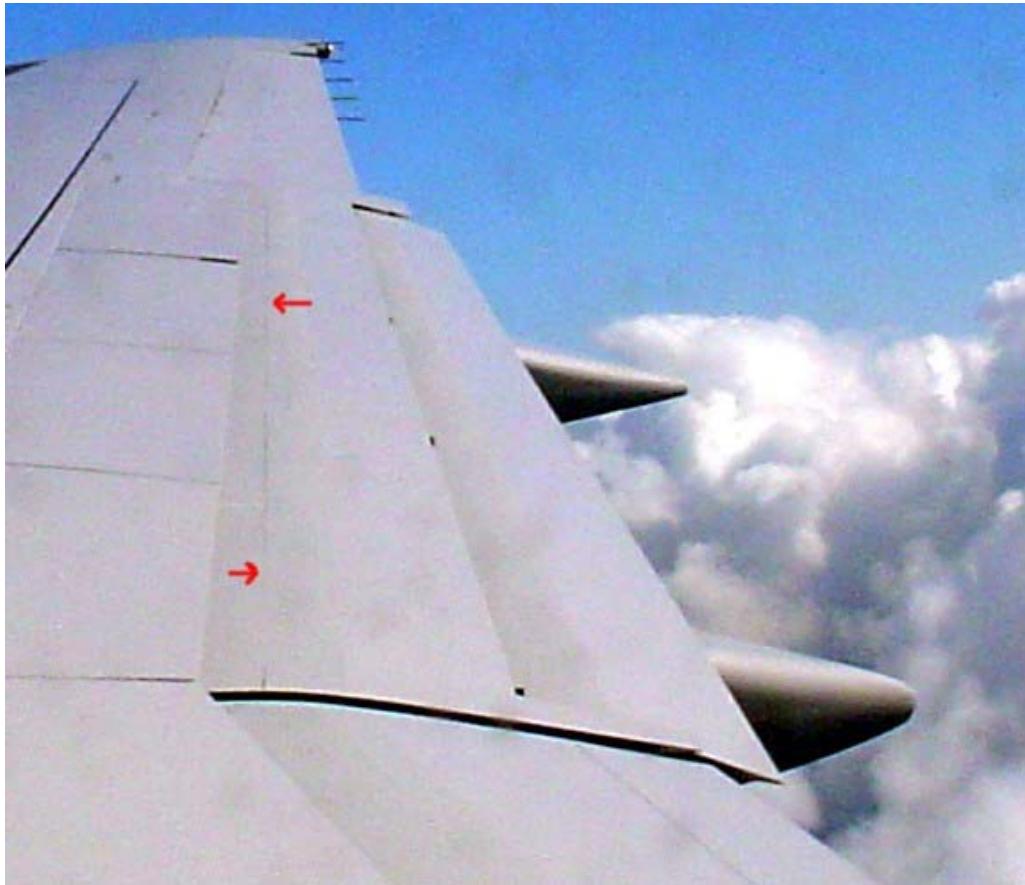
**Photo 2. Stress fracture on 757 outboard flap**

A linear stress fracture parallel with the rivets can be seen extending virtually the entire length of the outboard flap, which is about 23 feet (7m)\*. There are several sets/rows of rivets on the flap that are readily seen with the eye\*\* but not with the camera. This stress fracture was positioned close to the last set. Another photo is on the following page.

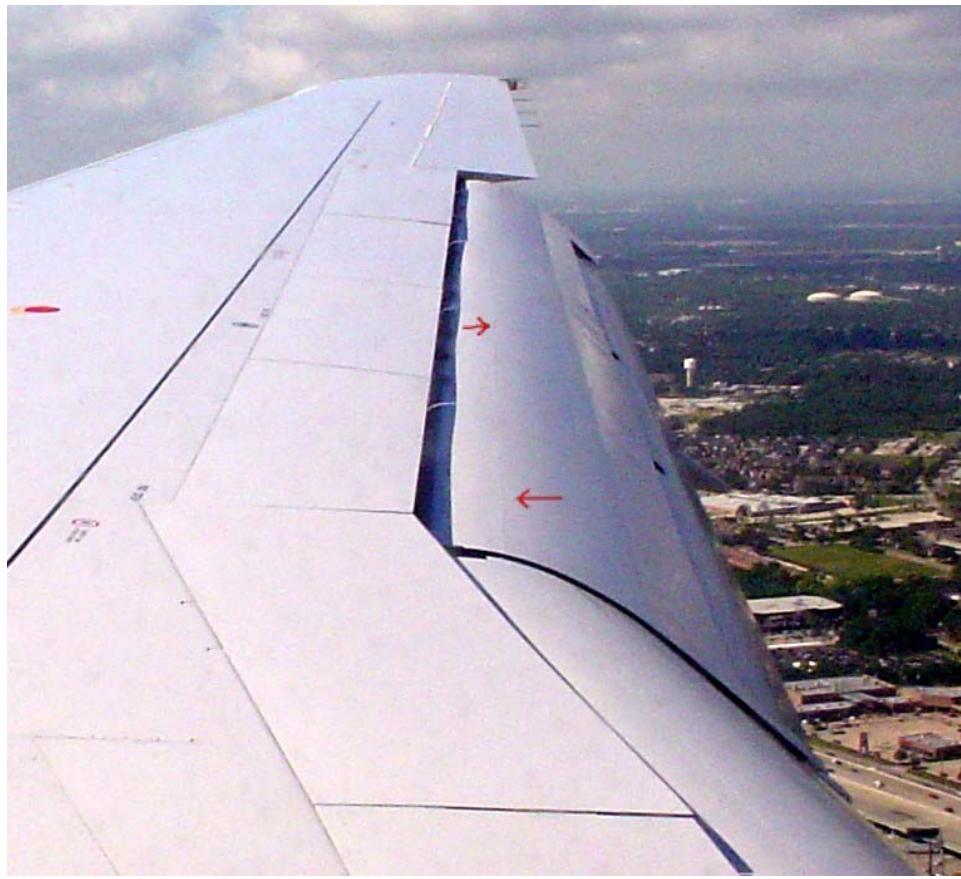
**Photo 3. Stress fracture on 757 outboard flap fully deployed for landing**

Note that in this enlarged and enhanced photo the fracture, due to the lighting, does not appear as a black line as in the previous image. It appears as a distortion resembling a wrinkle. This subtle feature is best seen on a monitor screen and may not be evident when printed.

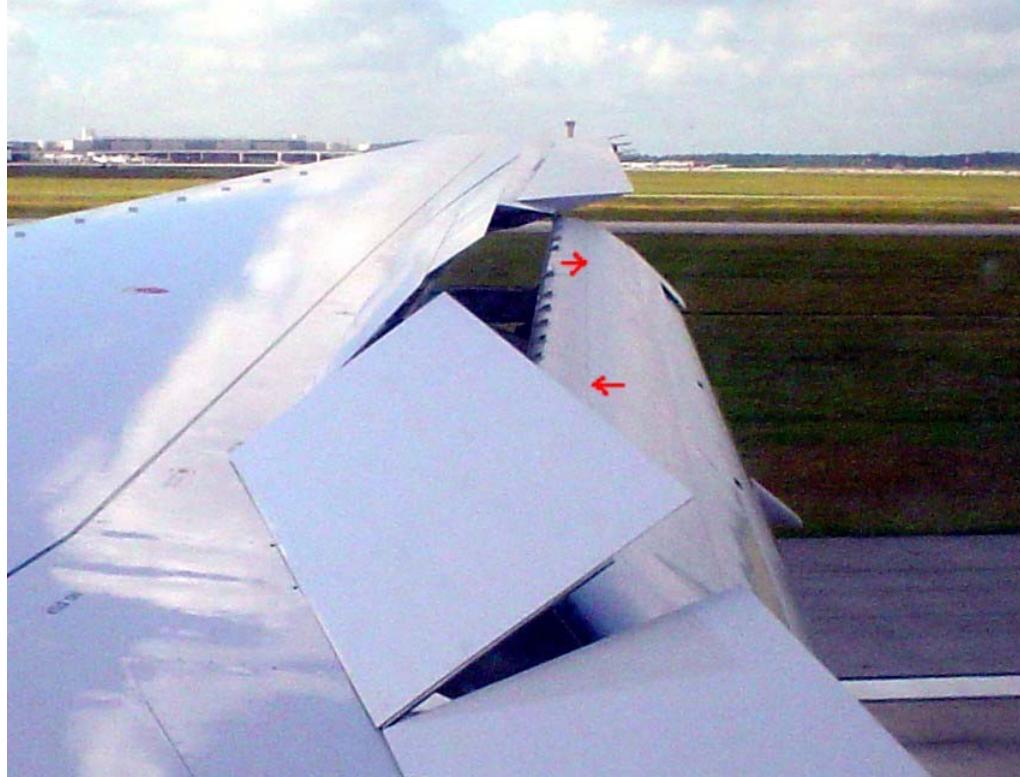
**Photo 4. Fractured flap after landing**

Here is another enlarged and enhanced picture of the same flap, this time after landing. Spoilers are up and flaps are down. The fracture is more distinct probably because of a reduction in surface glare caused by momentary cloud cover. The fracture width appeared to be in excess of 1/3 inch ( $> 8$  millimeters). It was widest nearest the fuselage, and the fracture surface edge appeared to be metallic and shiny as when weathered aluminum is freshly torn. It was not oxidized/corroded like other areas of the aircraft. The possible point of origin appeared to have somewhat of a circular hole configuration and was nearest the fuselage (Photo 5 below). From here the fracture propagated essentially parallel with the rivets to the opposite ends of the flap. As previously mentioned this length is approximately 23 feet (7m).

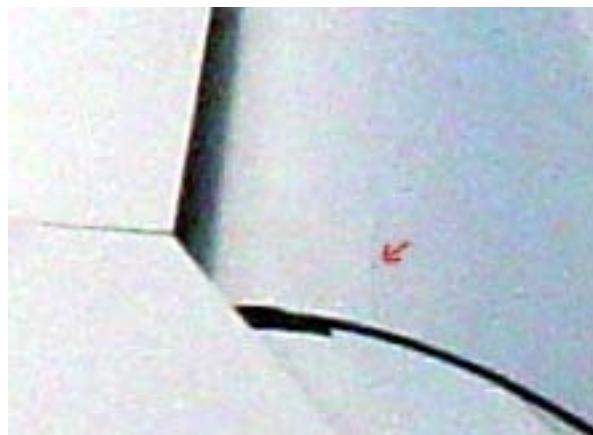
**Photo 5. Possible point of origin of fracture**

While taxiing to the gate the spoilers were lowered and the flaps were retracted, the latter into the wing. This is undoubtedly standard operating procedure which, in this case, hides the stress fracture. Thus, it would not be seen by ground service personnel or by the pilot during a “walk around” inspection with flaps up prior to departure of the next flight. That procedure needs to be reviewed. But it is questionable if the damage could be seen from ground level looking up because of its high position on the flaps. Although readily visible from seats over the wing, at ground level one may need to step back a bit to view it, like geologists and geophysicists do when we are looking at seismic cross sections.

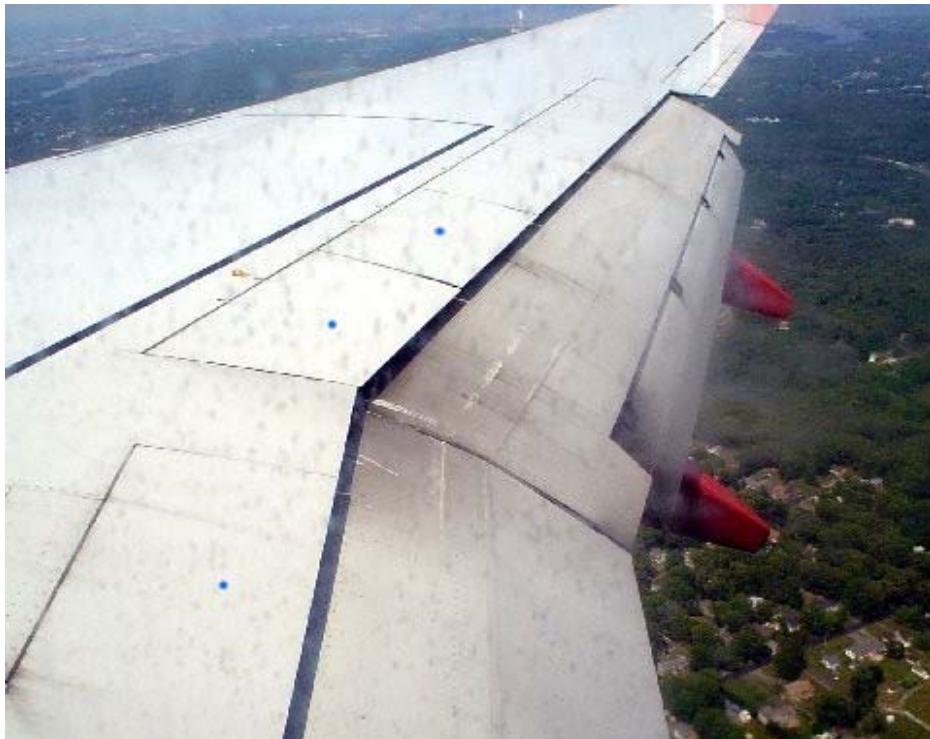
**Photo 6. Shadows cast by 737 spoilers on undamaged flap**

Another observation was noted. For this one we will use a Boeing 737 photo in lieu of an unavailable undamaged 757 in the file. This picture (also enhanced) was taken on another flight using the same camera. Specks are caused by dirt on the window. The outboard and inboard flaps on this smaller wing have been extended for landing. Note the straight shadows cast on the undamaged flaps by the spoilers (several spoilers are shown by blue dots). Compare this to another enlarged and enhanced photo (next page) of the fractured 757 flaps.

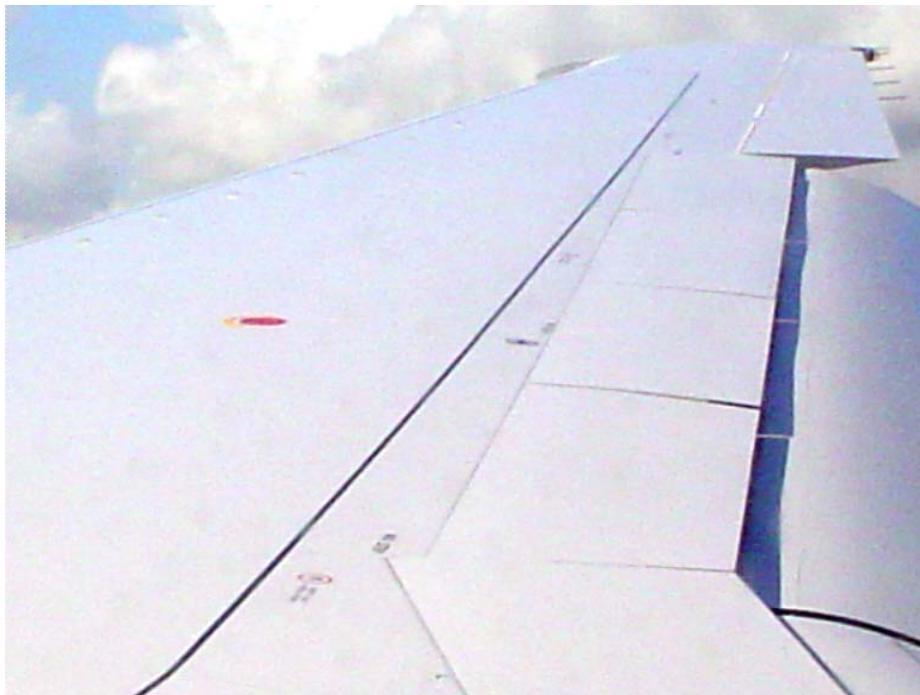
**Photo 7. Shadows cast by 757 spoilers on damaged flap**

The spoilers are straight but not the shadows (see also Photo 3). They are undulating (in waves). The most likely cause of this is a washboard or rippled-type surface on the flap (highs and lows in the aluminum skin), which is directly related to the damage resulting from the fracture. Indeed, some of the aluminum appeared to be torn and raised. These surface features could indicate a structural and/or mechanical problem with the flap.

So, you are a passenger with images of something wrong taken by an obsolete camera with a postage-sized viewing screen. You can't use it. What do you do to convey the information to the pilot after landing — sensibly and without possibly being detained and questioned by airport security and miss your connecting flight? You do what geologists are usually good at — you draw it, like you have done for years with structure and isopach maps. Then you take a chance and wait for other passengers to depart the plane and request to speak to the Captain. Always go right to the top if it is something you believe is critical. (Unlike other professions, damaged egos from being wrong are rarely a deterrent to geologists. We seldom hesitate because, despite all the technology, our success rate on rank exploration/wildcat wells is less than 15%. That's a lot of "dry holes", and we're used to taking chances). Be direct with the information, brief and to the point, and then leave. Fortunately, in this case the Captain, in the presence of another flight crew member, looked at the drawing (on a post-it note) as the fracture geometry was explained, listened intently, asked where it was, and then stated that the flaps would be pulled down [and checked].
